# barn facts & figures

# Welcome to Medieval Frindsbury Barn

One of the Few Surviving  
Great Barns  
of  
Medieval England

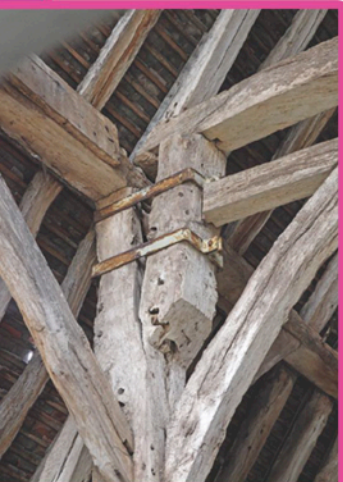
Typically the jowl is formed by using an upside down trunk to make use of the wider girth at the base of the tree. The jowl can be subject to significant forces as can be seen in the failure of the joint pictured left, where the tie beam dovetail has popped out of its locating pocket in the arcade plate.

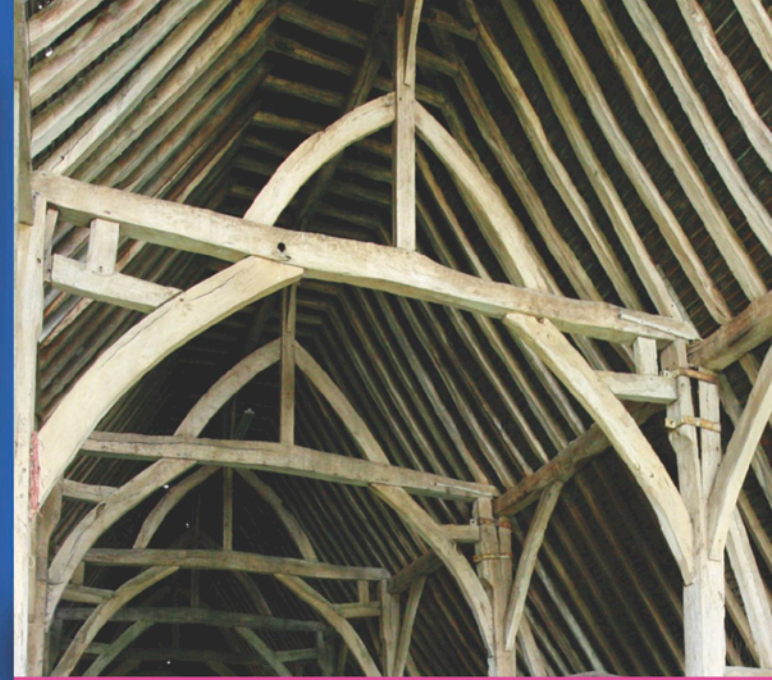
carpenters' marks

The original carpenters' marks, which were employed to help with the assembly and marriage of the joints, were incised on the tenon and thus hidden within the joint itself. Analysis subsequent to the fire damage has revealed them for the first time in 600 years. This detail is unusual and consistent with high status carpentry of the period.
