# Manor Farm Barn and outbuildings, Manor Farm, Frindsbury, Kent.

## Heritage Statement

Report No: 2020/141

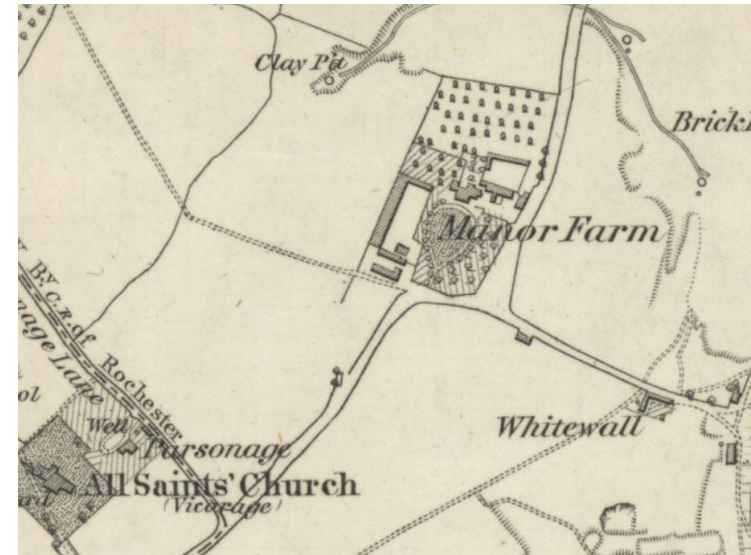
Map F: Detail of 1<sup>st</sup> Edition Ordnance Survey c1869 (6 inch).

Map regression analysis indicates the cowshed was formed in the late nineteenth century, between the 1<sup>st</sup> and 2<sup>nd</sup> Edition *Ordnance Survey* (Maps F and G). Evidently it replaces an earlier smaller building in this position (Map C). The structure comprises a long, narrow, single-storey range, covered with a low pitched slate roof. The shed walls are formed from yellow stock bricks and are pierced, on the yard (west) side, by various doors and windows. The interior is now largely open throughout its length and has clearly been refurbished since the nineteenth century, now accommodating stalls and a long concrete feeding trough against its east wall, with mangers above, and a paved floor with an open drain below. The structure is considered of low historic interest and was not studied or recorded by the Trust.

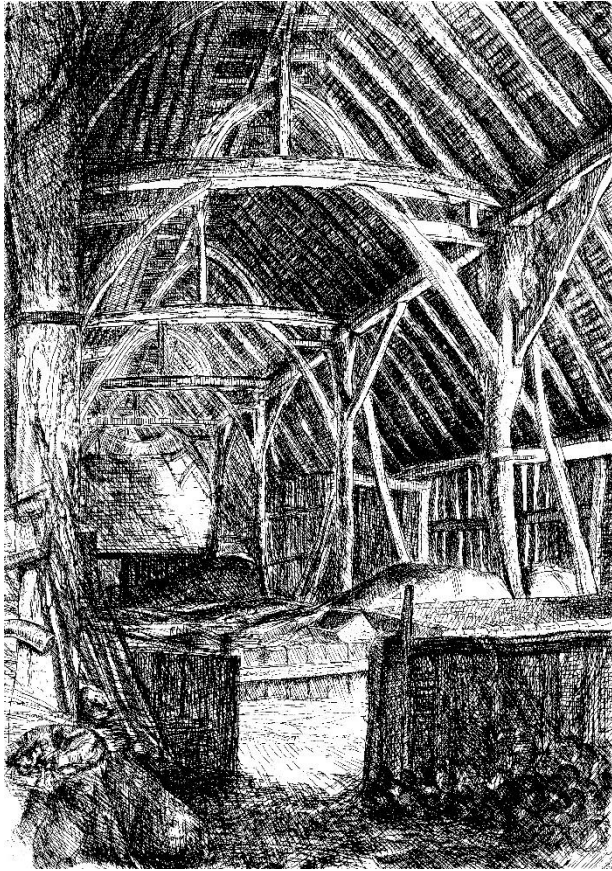
Pl 3: Engraving of barn interior, by Mary White, showing inserted partitions.

No evidence for medieval partitions has been observed within the barn, but partitions were introduced in later years, albeit of a rather rudimentary nature. None have survived, however, a sketch, titled *The Old Barn, Frindsbury*, by Mary White, shows the barn interior interrupted

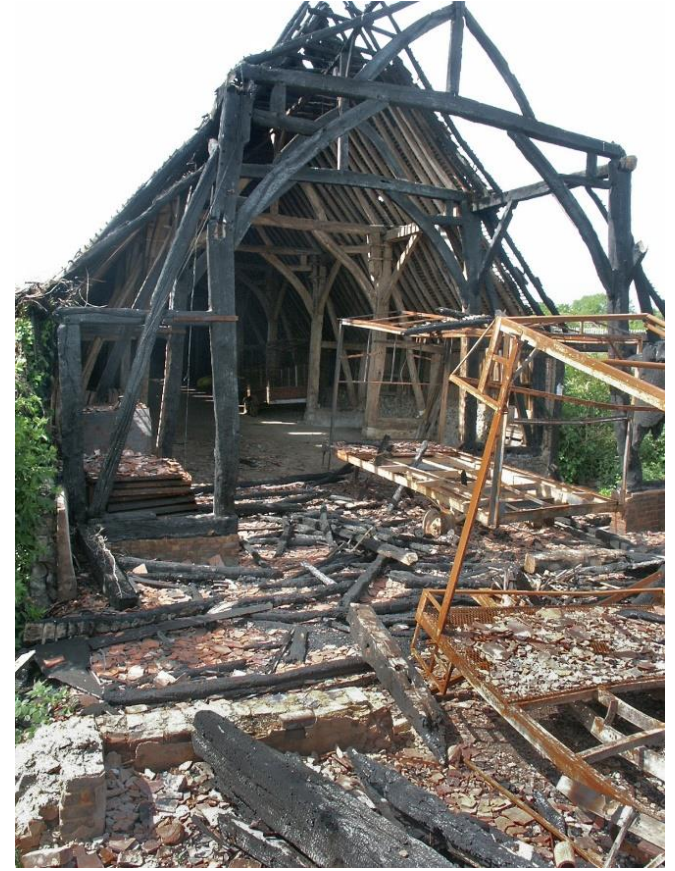
Pl 5: North end of barn after the fire of 2003.

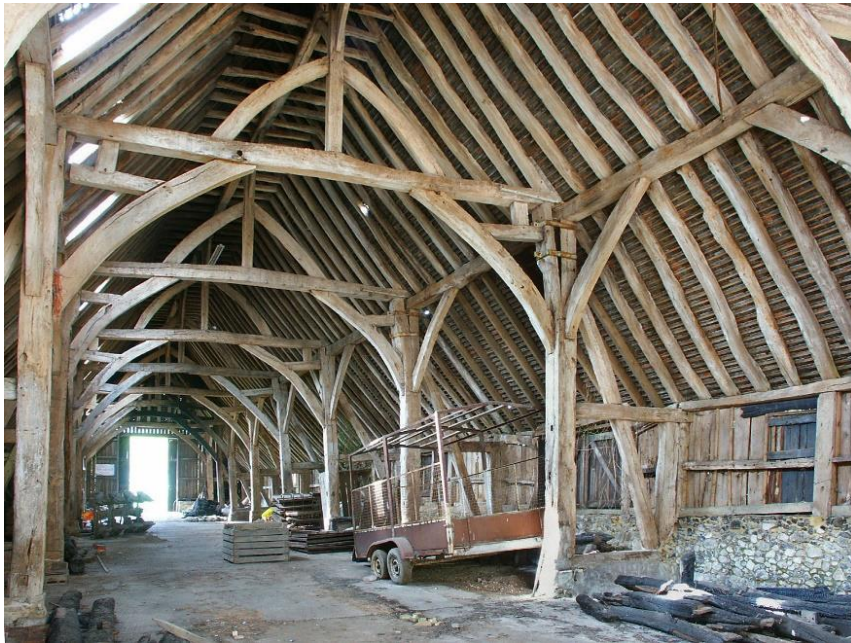
Pl 6: 2003 view of barn interior, looking south, towards surviving medieval bays.

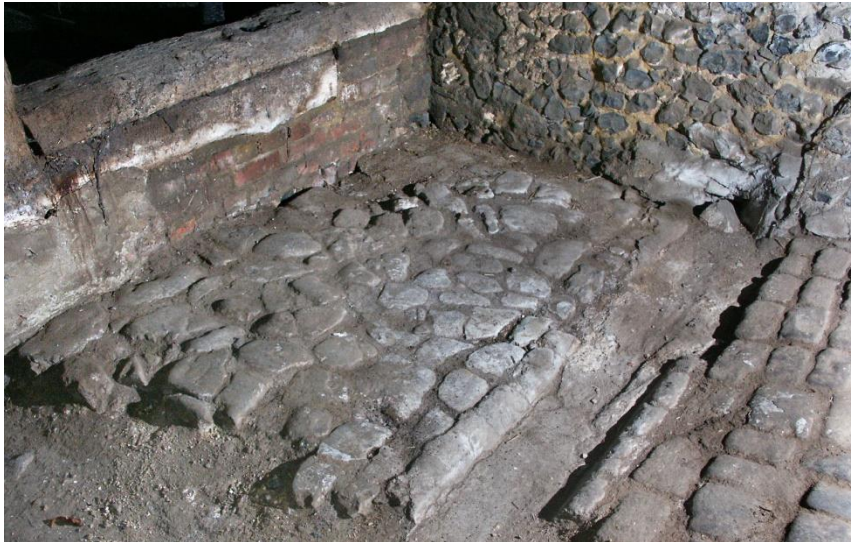
Pl 7: Remnants of Kentish Ragstone paving and open drain in south aisle of barn.

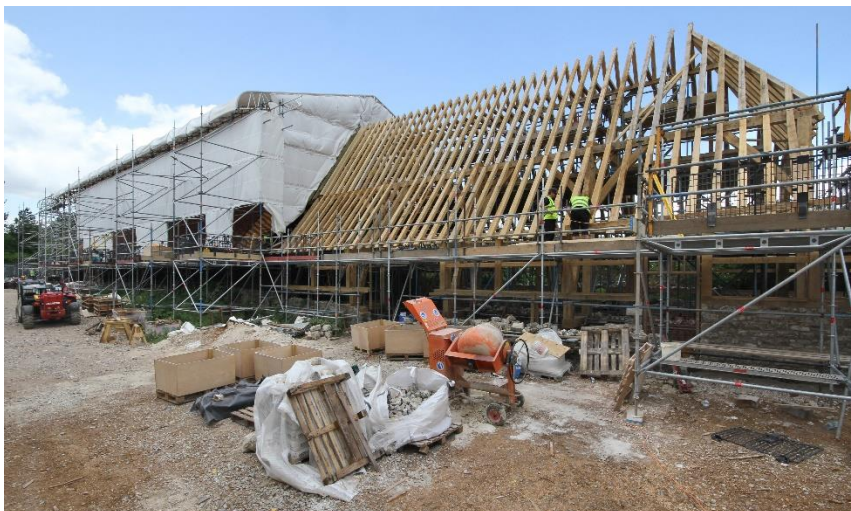
Pl 8: North end of barn, showing bays 1-4 during reconstruction in 2019.

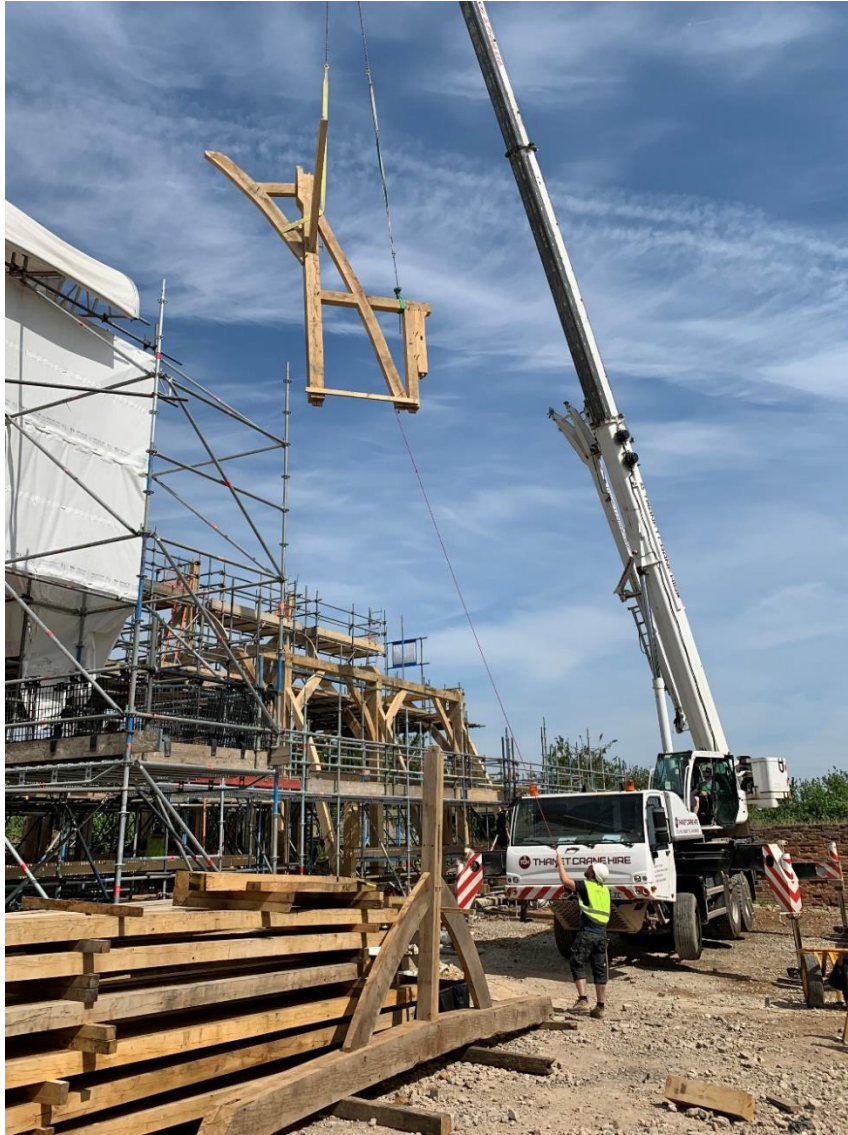
Pl 9: New oak framing being hoisted into position at north end of barn during restoration in 2019.

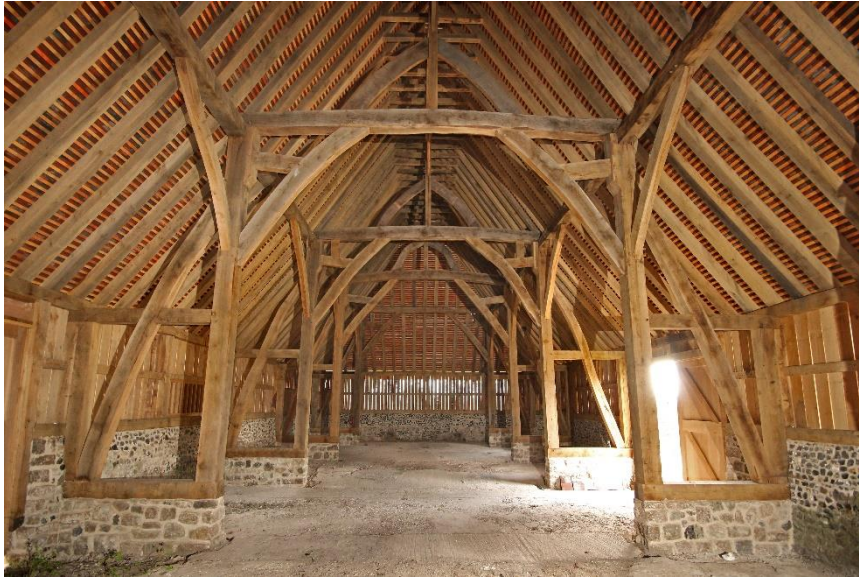
Pl 12: Interior of restored northern bays of barn, looking north in 2019.

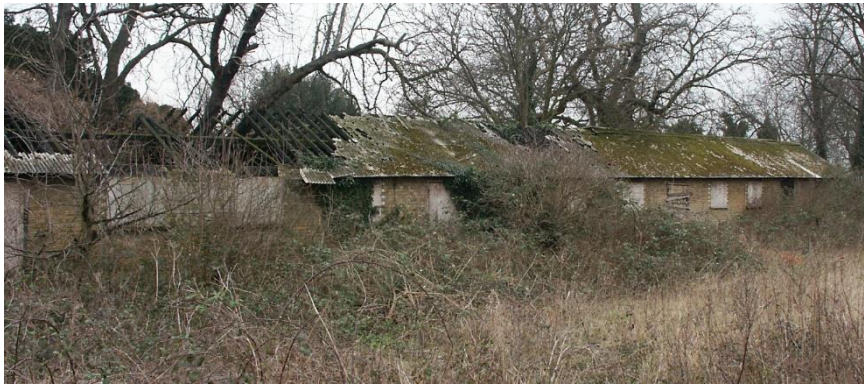
Pl 13: General view of cattle shed, looking east.

The low historic interest of the structure presents few concerns, and its conversion would appear wholly acceptable, however, it will impact the setting of the barn, given it faces the yard. The design of the conversion should be sympathetic with the barn and in keeping with the agricultural nature of the site (the proposed design, resembling a row of stables and would seem suitable). Although of low historic interest, a brief photographic survey and written description of the structure, prior to its conversion, is recommended.

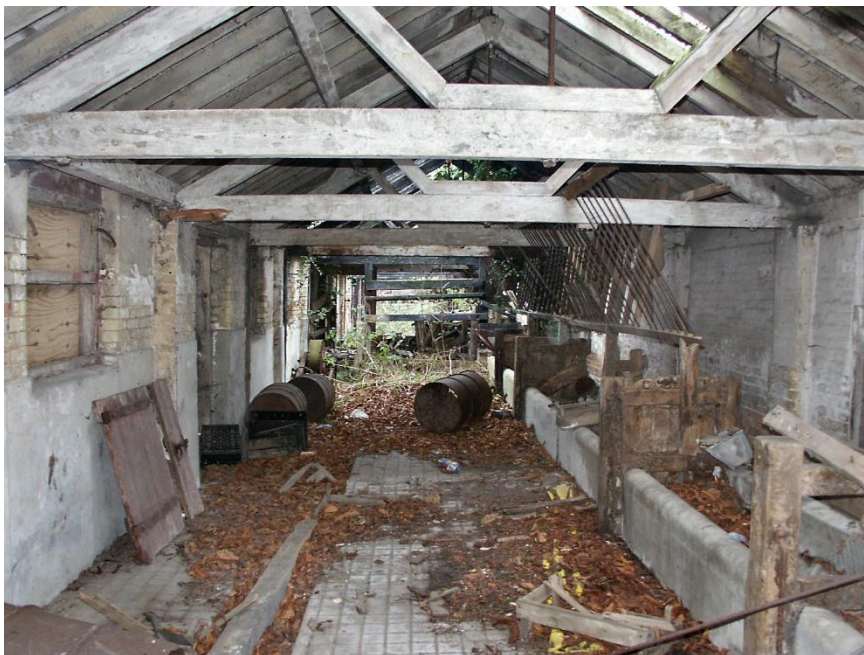
Pl 14: Interior of cattle shed, looking south.
